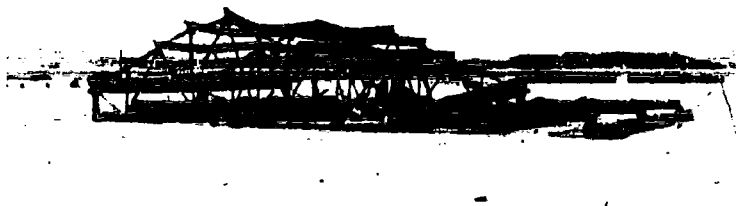
Figure 2.6 Posttest, TP 3.7 a-1 structure, front side view, facing northwest.

The TP 3.7 a-1 structure collapsed in a direction away from ground zero (Figure 2.6). All the column-to-foundation connections held, although two appeared to be on the verge of failing. All surfaces facing ground zero were charred and severely pitted. End column-to-truss connections on the ground zero side remained secure; the failure occurred by separation of the column flange from the web combined with a tension failure of the column web and one flange. The interior column truss connection at the lower chord failed by a combination of angle tearing and bolt failure. The upper chord members tore away from the column connections. All the roof purlins were bowed to some extent. The bowing of the roof purlins on the ground zero side was more pronounced; they had approximately a 1-foot center displacement in a plane parallel to the ground. The lesser displacement of the purlins on the lee side of the roof was probably indicative of a reduced blast loading because of shielding from the upstream members. There was some lateral bending of the crane rail beam on the lee side of the structure. This may have been because the tie rods in the bottom plane of the roof trusses transmitted a portion of the weight of the structure to the crane rail beam approximately at mid-span as the structure collapsed. All columns on the lee side of the structure buckled in the vicinity of the lower chord-to-column connection.

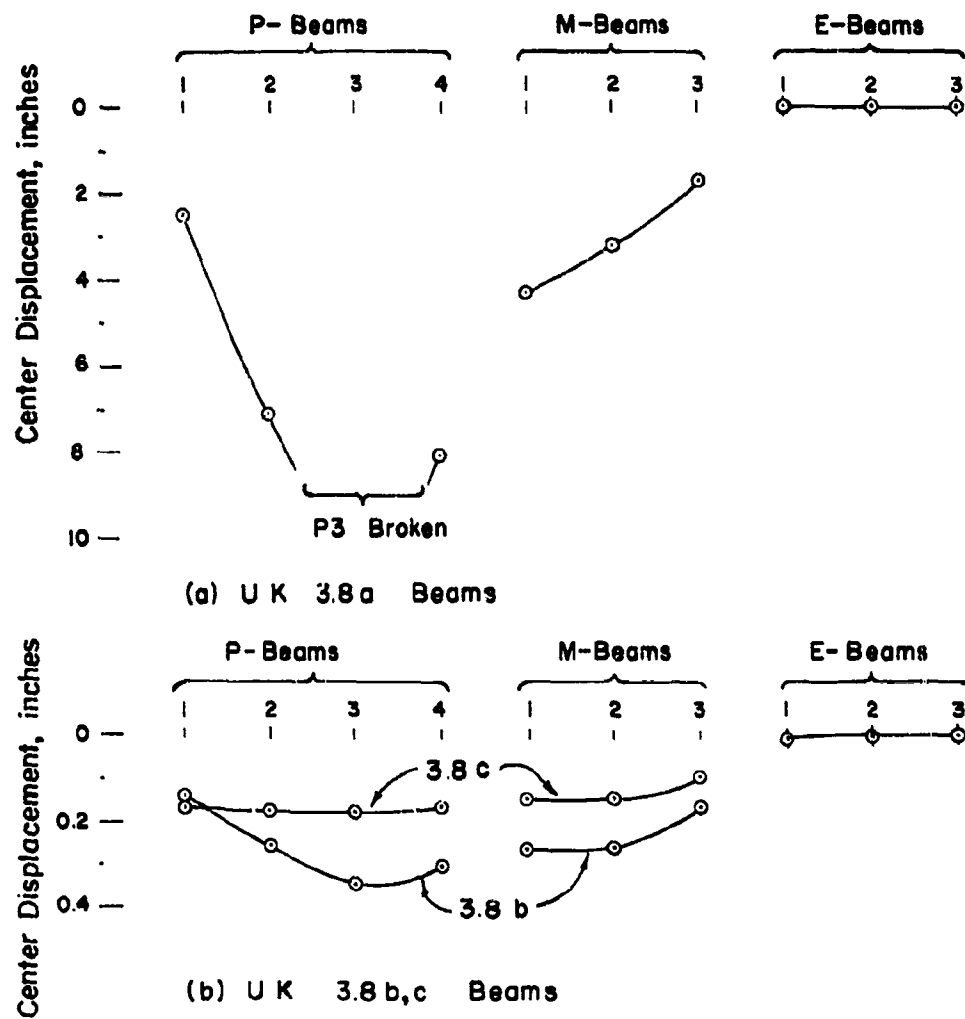
Figure 4.12 Variation in center displacement of UK 3.8 test beams along length of structure.

Another conclusion reached in earlier tests was to the effect that the beams behaved as though loaded with the vertical forces acting on the earth's surface immediately overhead. In view of the significant variation in response of presumably identical beams in the same structure (Figure 4.12), it does not seem reasonable to assign only a passive role to the soil in regard to the transmission of vertical pressure.

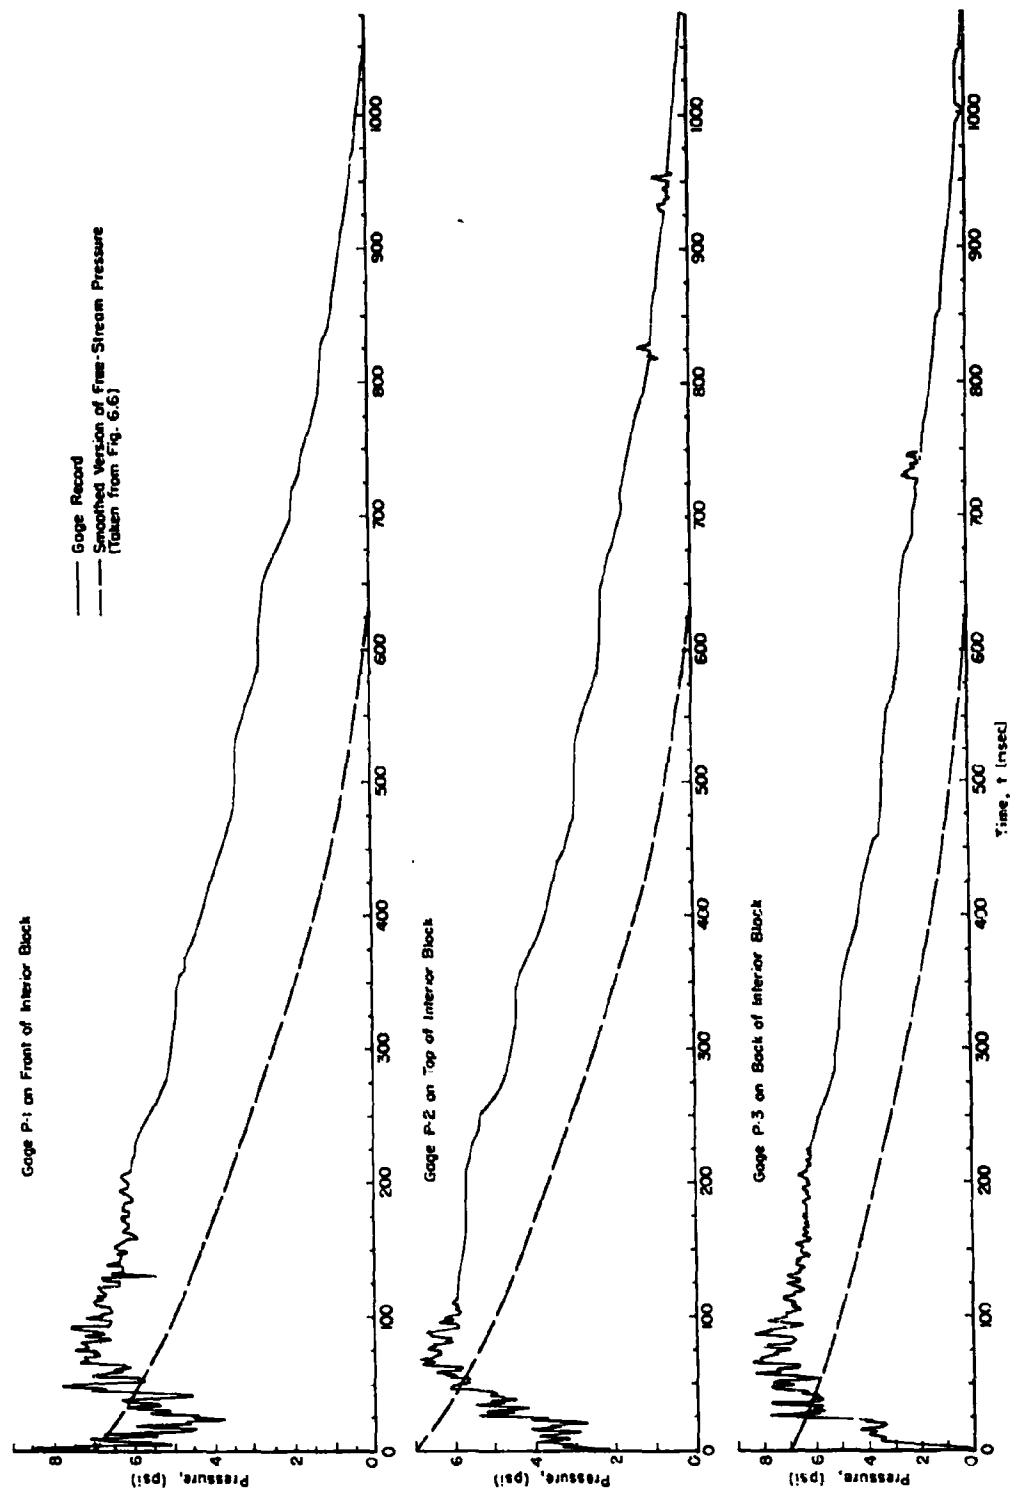
Figure 6.4 Pressure-time records of various gages.

6.2.1 Free-Stream Overpressure. A smooth curve approximating the free-stream overpressure obtained from Gage P6 is superposed upon the reading of Gage P1 in Figure 6.4. It can be seen from this figure that the nature of the pressure decay and the positive phase duration indicated by Gages P1 and P6 differed considerably. Although a similar difference in wave decay and duration was observed by comparing the records of the other two electronic Gages P2 and P3 with the static pressure record of Gage P6, the record of Gage P4 located in the center of the floor of the empty cell did not disagree radically with that of Gage P6. The three electronic Gages P1, P2, and P3, mounted on the interior block, showed durations of roughly

1,000 to 1,100 msec. This was considerably different from the durations of about 650 msec for Gage P6, 850 msec for Gage P4, and about 800 msec for the blast line and other free-stream monitors located at a ground range in the neighborhood of 4,200 feet.

It is immediately evident from Figure 6.4 that no reasonable analysis of the records from Gages P1, P2, and P3 could be carried out unless the wave shape and duration were either elongated for Gage P6 or compressed for Gages P1, P2, and P3, so that the durations become approximately equal. By making this type of equalizing modification of the durations and wave shapes, the records could be analyzed satisfactorily, at least for the first 100 to 200 msec of loading. Since the diffraction phase of the loading was completed by this time, one could conclude that the records supplied satisfactory diffraction information but were inadequate for the drag phase analysis.

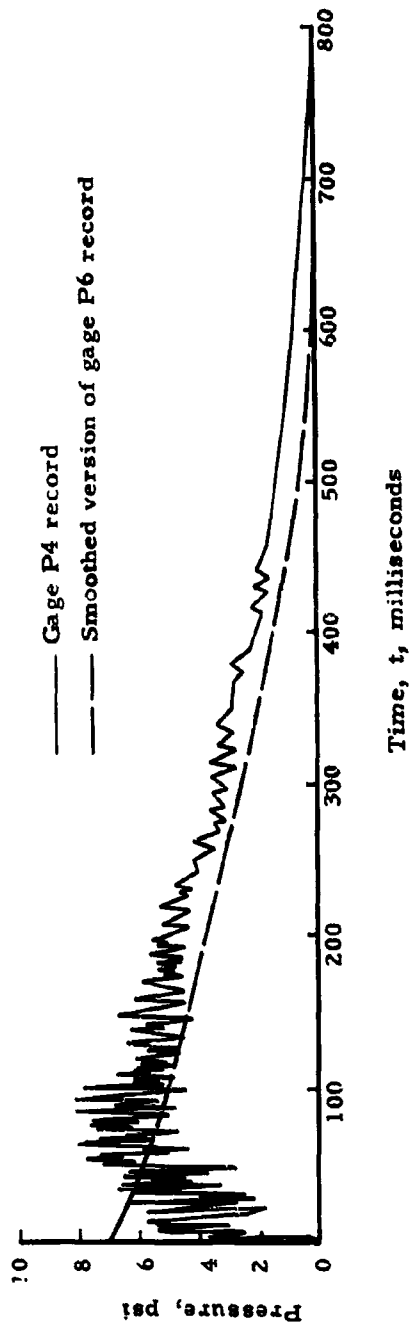
Figure 6.5 Pressure-time record of gage P4 at center of floor in empty cell.

6.3.1 Pressures in the Empty Cell. The pressure-time variation at the center of the floor in the empty cell (UK 3.5ba), shown in Figure 6.5, constituted the interior free-stream wave incident upon the 2-foot cubical located in the other cell (UK 3.5bc). The multiple reflections incident during the initial portion of the gage record probably resulted from the interaction of the shock with beams and pilasters within the test structure. The presence of the initial wave, the reflected wave from the back wall, and the re-reflected wave from the front wall can be observed in Figure 6.7.

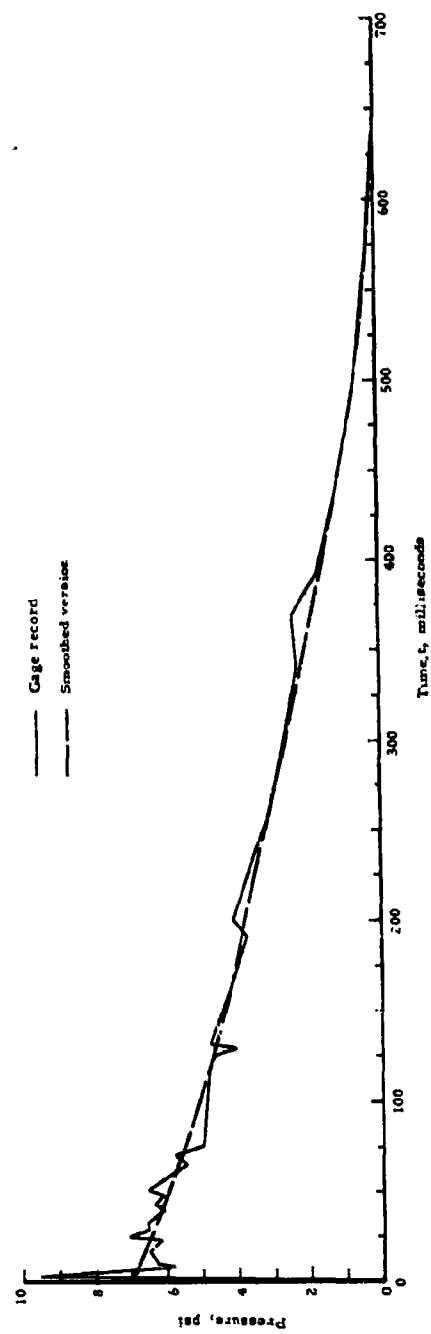
Figure 6.6 Free-stream static pressure record of gage P6.

7.3.1 Pressure Records. Consideration of the pressure data alone served to point up the influence of frangible wall covering on the form of the entering blast wave. The free-field-pressure record shown in Figure 6.6 indicated a clean Mach wave of 7 psi overpressure and 0.63 second duration. The brief record obtained from the gage behind the corrugated asbestos panel indicated a wave with essentially zero rise time and a peak pressure corresponding to the incident exterior wave. The panel failed almost immediately and, insofar as its effect on the interior wave form was concerned, it might as well have been absent entirely. (Actual break times for the test panels may be inferred from the data of Reference 15. For transite, this time appears to be less than about 20 msec, and less than about 30 msec for the cinder block wall.) Thus the rear 12-inch brick wall failed under an incident shock of approximately 7 psi overpressure. However, prior to collapse, the wall was capable of reflecting a shock wave of 14.0 psi overpressure. The failure of this wall, therefore, did not compromise the results of the test. The pressure gage failed at this time, possibly because of being struck by wall debris. Had the rear panel not failed, the reflected pressure from the rear wall would have led to a series of oscillations between reflected and zero overpressure.

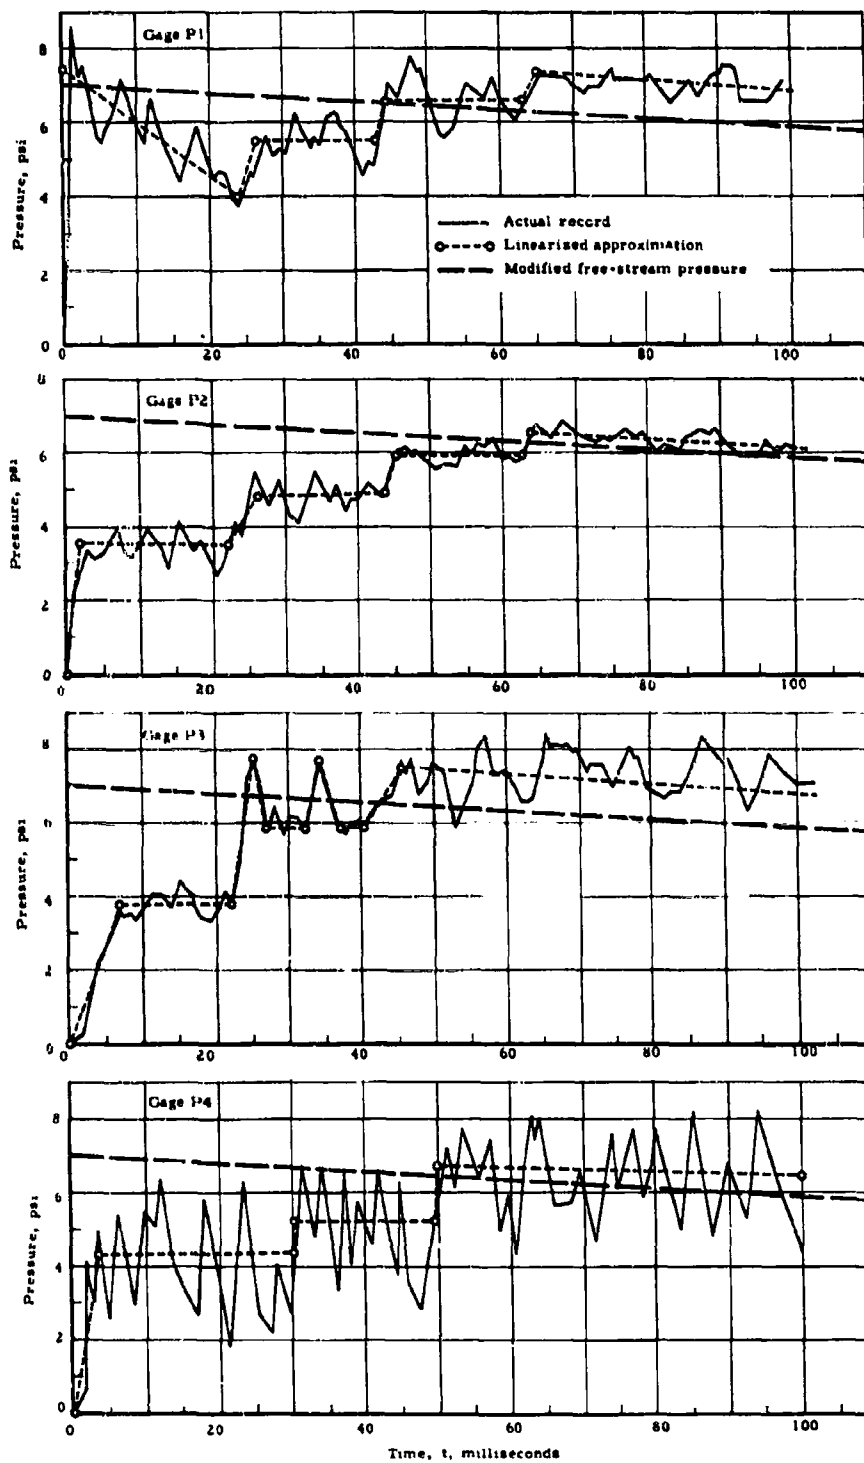
Figure 6.7 Diffraction phase pressure-time records of various gages.

6.2.2 Linearized Pressure-time Curves. Enlarged plots of the early phase of the loading as measured by Gages P1, P2, P3, and P4 are shown in Figure 6.7. Linearized approximations to each of these gage records and the modified smooth approximation to the outside overpressure are superposed.

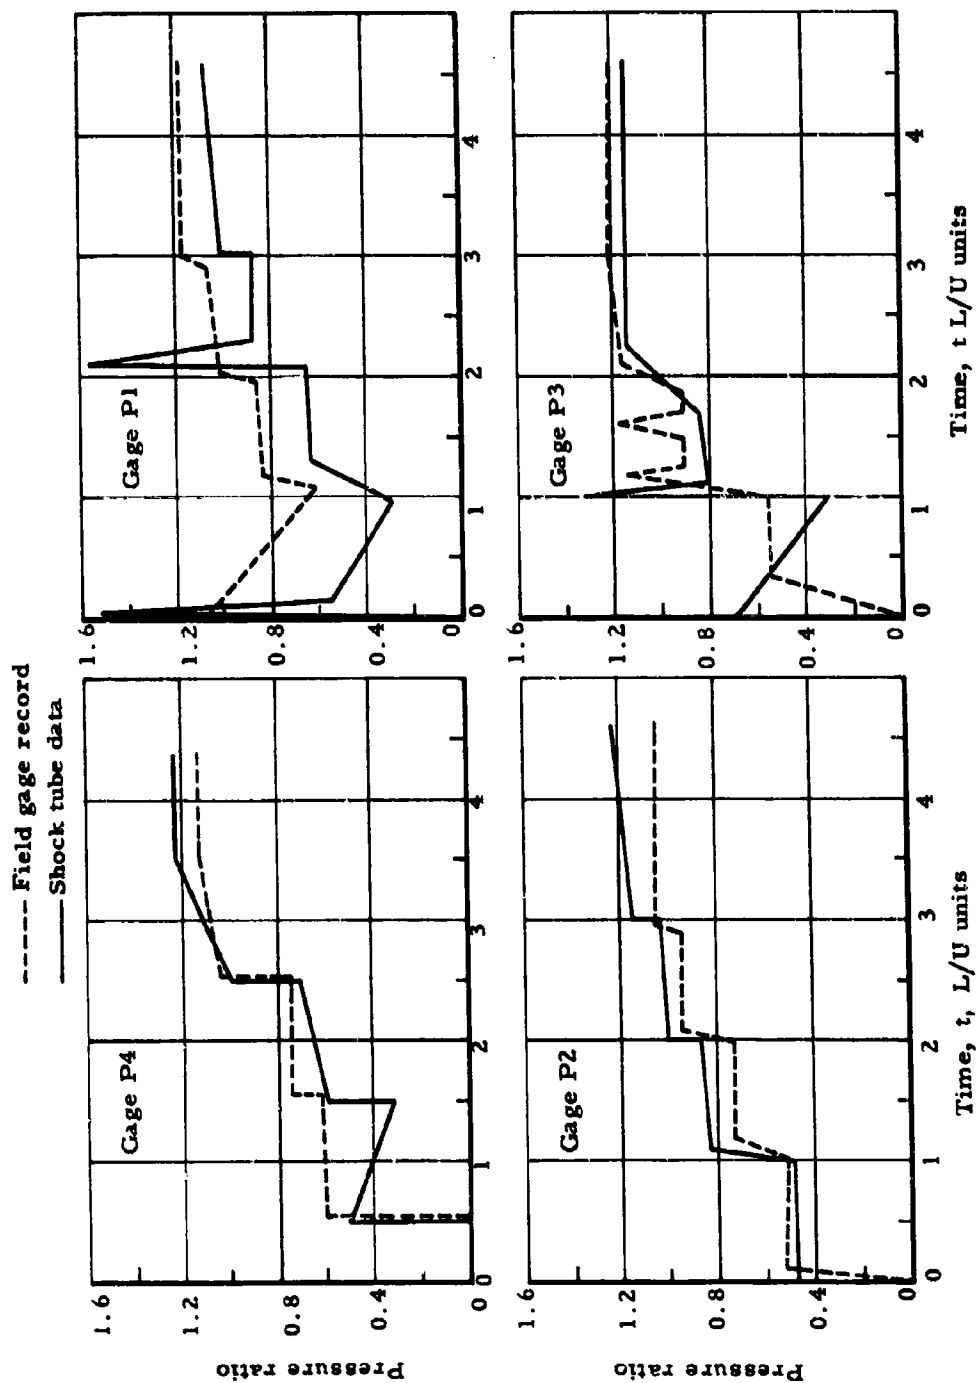
Figure 6.8 Comparison of linearized pressure-time data at various gage locations.

Figure 6.8 shows the comparison of linearized shock-tube and field results of the normalized pressure-time variation at the center of the floor of the empty cell. The initial inside pressure (unless otherwise stated, inside pressures refer to the plateau values of the linearized traces; initial inside pressure refers to the first plateau) was of about the same magnitude for the field and shock tube, i.e., about 0.6 and 0.5 psi of side-on pressure, respectively. The shock tube pressure decreased to about 0.32 of outside free-stream overpressure, before rising to the second plateau at $t = 1.5 L/U$. At later times, the shock-tube and field-data inside pressure ratios were in good agreement. The shock-tube pressure ratio was slightly less than that of Gage P4 in the field structure until the rise to maximum pressure occurred, after which the shock-tube pressure became slightly higher than that in the field structure.

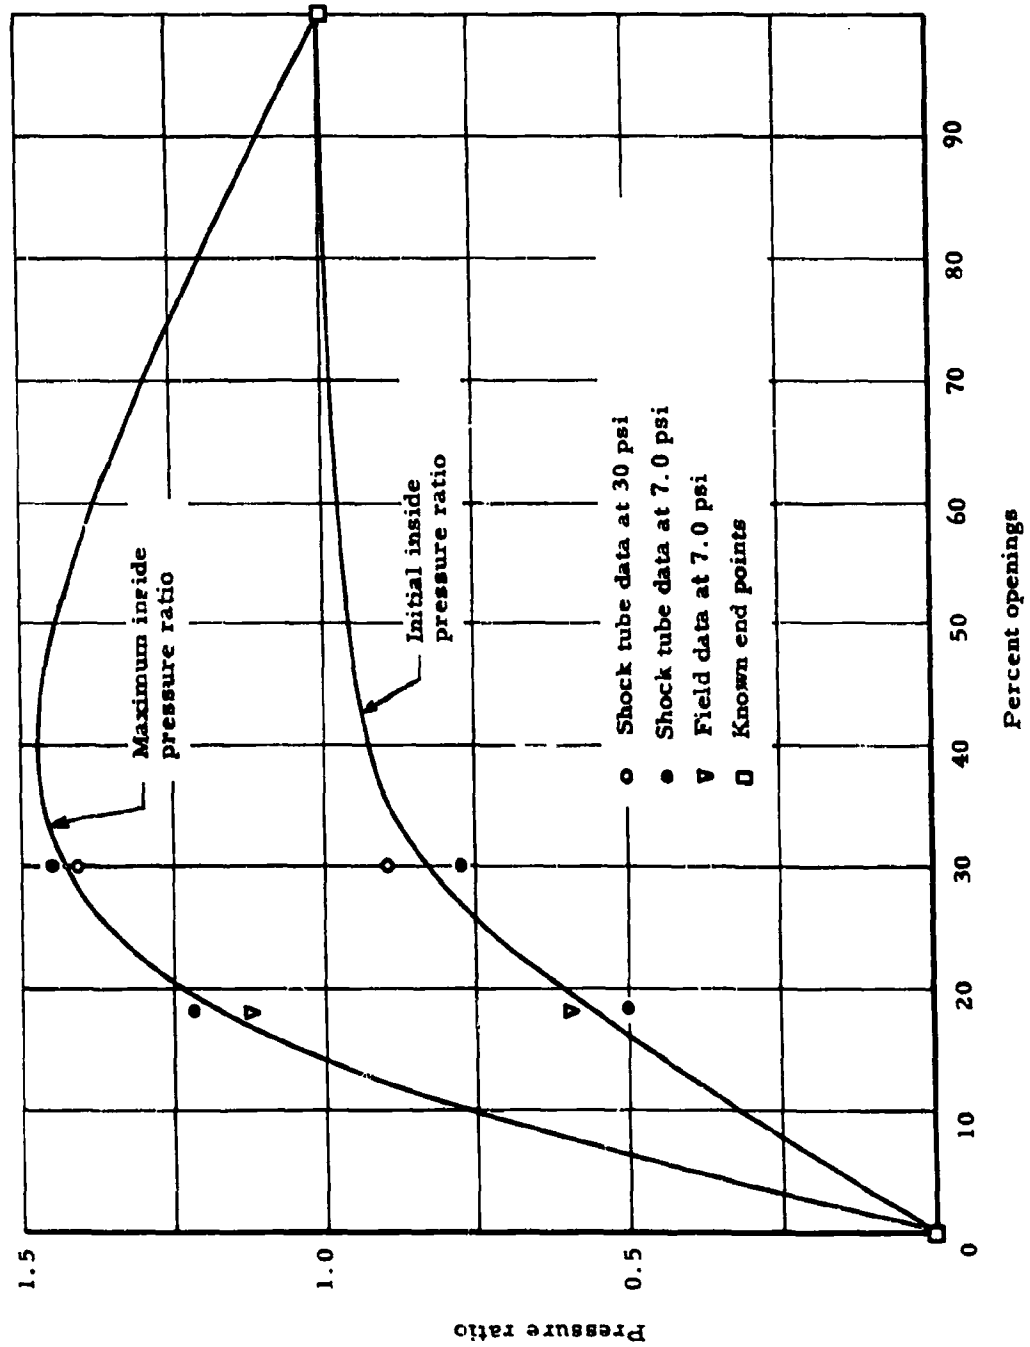
Figure 6.9 Inside initial and maximum pressure ratios versus percent openings.

Two quantities which are of interest in an interior loading study of this type are the initial and maximum inside pressure ratios. While the overall pressure-time build-up inside the hollow model is rather complex, a simple graphical relationship between these quantities and the percent of wall openings has been established (Reference 14). The results of a rather detailed shock-tube study indicate that both these quantities are, for all practical purposes, independent of initial outside overpressure in the range of zero to 30 psi. A plot of these two quantities versus percent of wall openings is shown in Figure 6.9. The curves deal with the pressure at the center of the floor in a structure similar to the 3.5ba cell. Also in Figure 6.9, the results obtained from the field test are compared to those of shock-tube tests on a model with equal openings in front and back walls. (Figure 6.8 also shows a comparison with shock-tube data from a model having a height-width-length ratio of 2:3:6 and 30 percent openings in the front and back walls (Reference 14).) The curves are drawn through known end points where the values of the abscissa are equal to zero and 100 percent. Although the shape of the curve for maximum pressure ratio is speculative for openings greater than about 40 percent, it is believed that the initial pressure-ratio curve is reliable for the full range of zero to 100 percent openings.

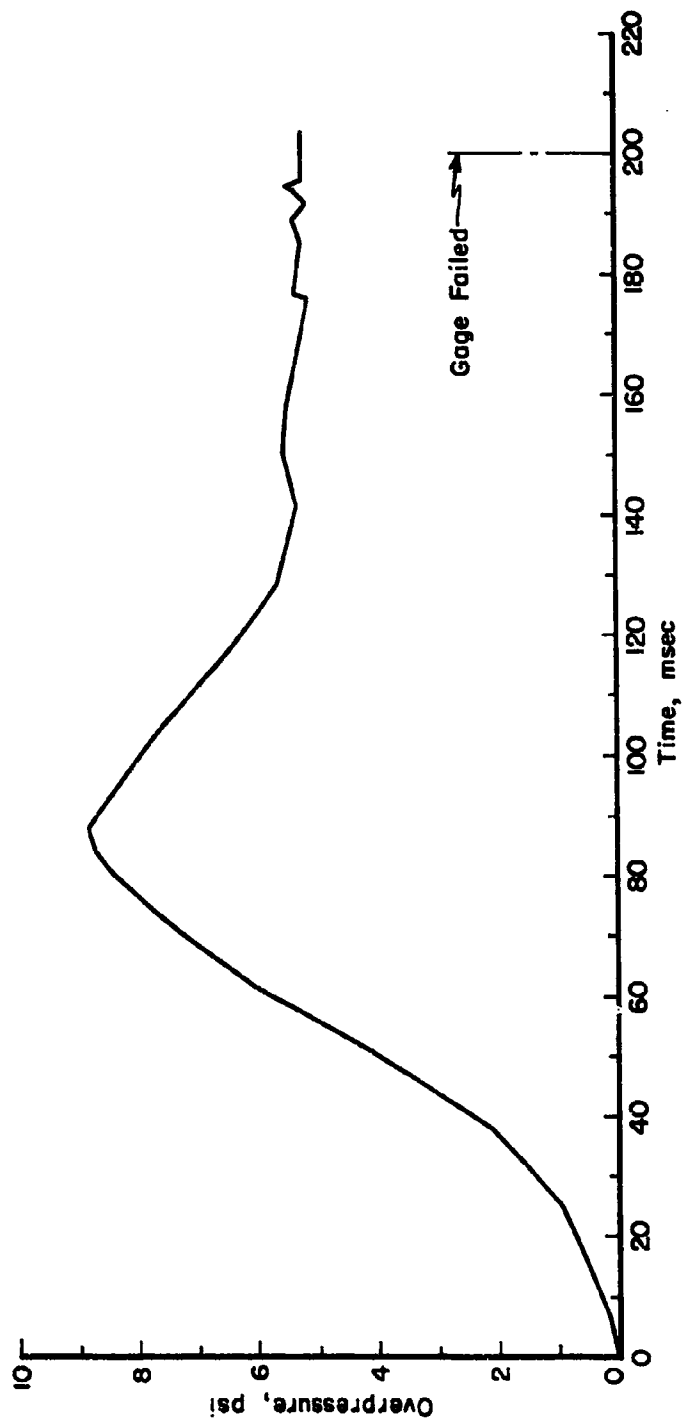
Figure 7.6 Overpressure versus time variation behind cinder block panel.

The pressure gage behind the cinder block panel provided a good record for the first 200 msec and then failed (Figure 7.6); fortunately, this covered the complete time range of interest. The gage behind the corrugated asbestos panel recorded a shock of 7 psi peak overpressure, being essentially zero rise time, and then failed immediately after responding to the reflected shock transmitted from the rear wall. The peak pressure recorded at this time was 14 psi. This brief record was not reduced in final form and is not shown.

The pressure record behind the failing cinder block wall, Figure 7.6, tells quite another story. While the cinder block was structurally a brittle or frangible material, its presence, even in failure, significantly affected the incoming shock. Figure 7.6 shows an interior wave that was evidently a compression wave having a rise time of 93 msec, and a total peak overpressure of 8.9 psi. This peak value already includes the effect of both the incident and reflected waves.

Although it was thus not possible to compare the measured maximum pressure and rise time with the shock tube results, a less direct comparison could be made. The pressure records obtained during the shock-tube tests showed the initial pressure build-up to be essentially linear for the condition of no reflection from the rear wall. Thus, the ratio of the predicted quantities, p_i/t_r , should be comparable to the initial slope of the pressure record shown in Figure 7.6. The predicted initial slope is

This value compares most favorably with the initial slope of 4.0 psi/100 msec obtained from Figure 7.6.

The quantitative prediction of maximum overpressures in a cavity, such as formed when the front wall fails under conditions where interior reflections occur within the rise time of the incoming compression wave, hinges on a rather elaborate analysis of the wave reflections in the cavity. For a flat-topped shock wave entering the cavity, a series of oscillations between reflected and zero overpressure is predicted and has been observed experimentally; these oscillations have a period of roughly $4L/U$, where L is the length of the cavity and U is the speed of shock propagation. For an essentially flat-topped compression wave, the reflection coefficients are virtually the same as for shock waves for overpressures less than 100 psi. A compression wave becomes steeper upon reflection from an infinite wall (Reference 19), and reflection from the closed end of a cavity is identical to reflection from an infinite wall until the reflected wave reaches the open end of the cavity. Even without reflection at a rigid boundary, a compression wave steepens into a shock wave in a finite time, since pressure signals in the interior of the wave are transmitted at higher velocities than are those at the wave front. Hence, where reflections in an open cavity interfere with the incoming pressure build-up, one would expect pressures at any station within the cavity to rise at an increasing rate during the first transit of a reflected pulse from the closed end. This behavior is evidenced in the pressure record of Figure 7.6.

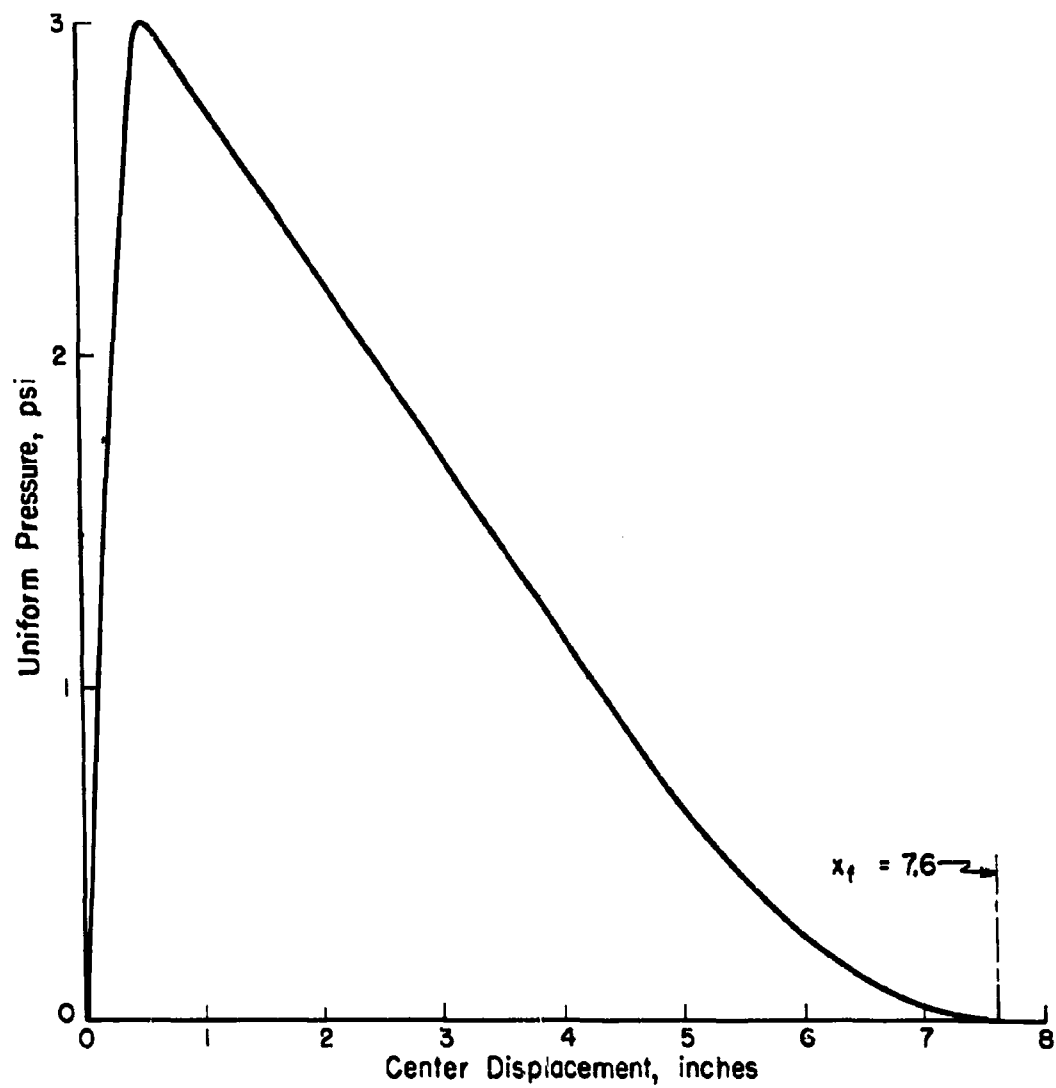
Figure 7.7 Predicted static resistance function for cylinder block panel.

According to the theory presented in Reference 18, the resistance of the cinder-block panel to transverse loads was generated by arch-like thrust forces developed at mid-span and at the panel supports. This led to a resistance function (i.e., load-displacement relation) that increased nearly linearly from zero to a maximum value and then decreased to zero. The resistance function for the test cinder-block panel was determined according to the methods of Reference 18 as shown in Figure 7.7.

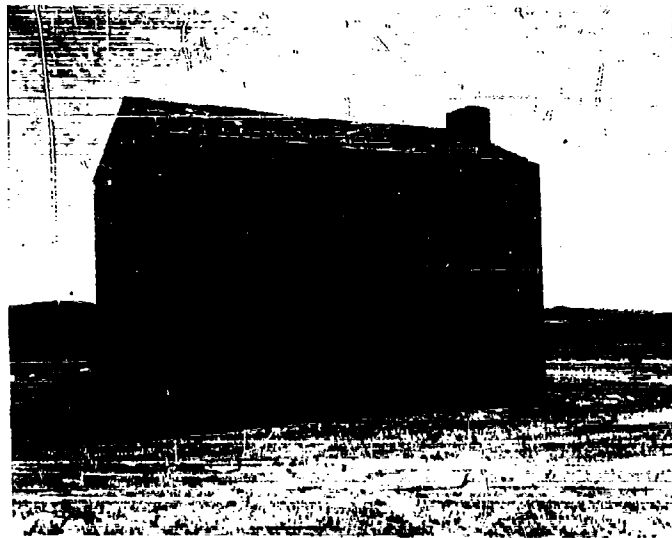
Figure 9.45 Posttest, TP 31.1 b-2, side view of building, facing southeast.

Posttest Damage: Virtually all the window and door covering was blown away. The exterior frame appeared intact, but the roof had deflected inward somewhat. Numerous shingles were blown off the roof (Figures 9.45 and 9.47).

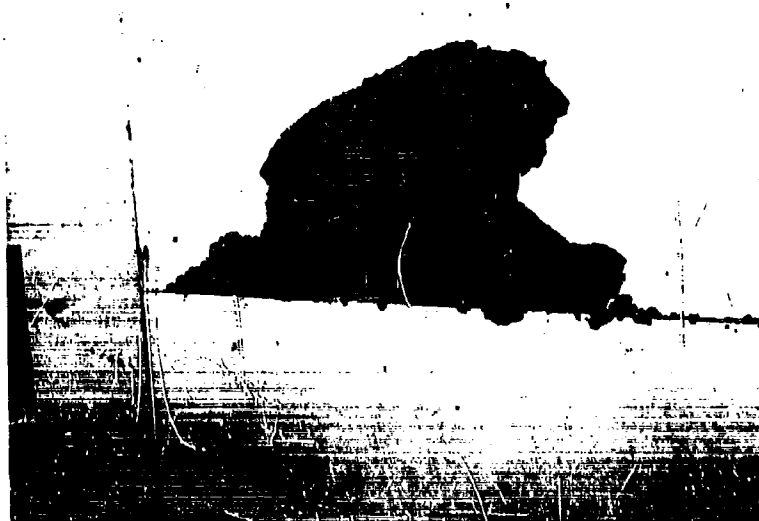
Figure 9.57 Posttest, TP 31.1 e-1, interior of living room, facing northwest.

Posttest Damage: There was some additional damage to the building. There was evidence of spalling of concrete from the ceiling panels at the joints and from the top of wall panels (Figures 9.57 and 9.58). Numerous radial cracks occurred around the window openings. There was some evidence that the interior partitions facing open windows had shifted slightly.

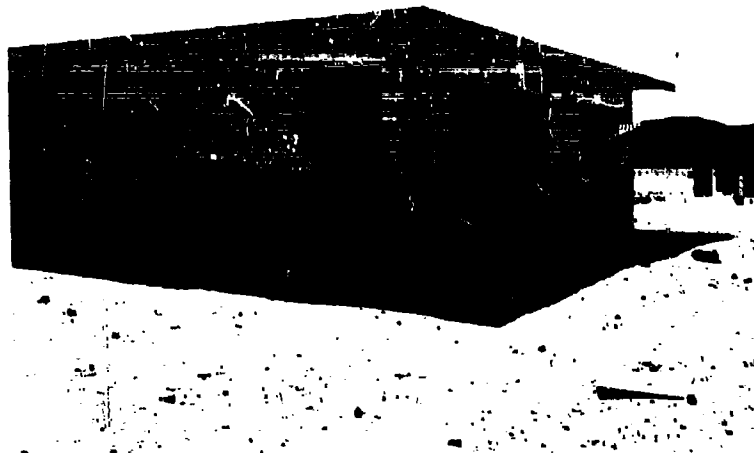
Figure 9.59 Pretest, TP 31.1 f-1, side view of building, facing southwest.

Pretest Damage: The building had sustained only slight damage. Minor cracks were evident on the outside of the front wall below the picture window (Figure 9.59). Several blocks had been removed from this area and the opening boarded shut (Figure 9.60). Most of the door and window openings were boarded shut (Figure 9.64). Some cracks and minor spalling were evident in the ceiling and walls.
